Organ Pipe Cactus  
National Monument

## **Effects of the International Boundary Pedestrian Fence in the Vicinity of Lukeville, Arizona, on Drainage Systems and Infrastructure, Organ Pipe Cactus National Monument, Arizona**

Prepared August 2008

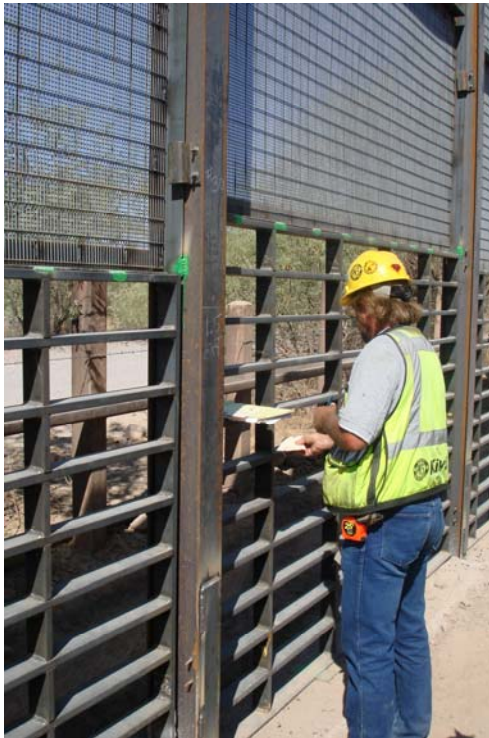
Panels at drainage crossings have grates that were designed to accommodate a flood event (Figure 2). Grate openings are 6-inches (in) high and 24-in wide, with 1-in by 3-in bars.

Figure 2. Fence panels at drainage crossings (above) have wire mesh above larger grate openings intended to accommodate flood flows.
